DEPARTMENT OF TRANSPORTATION

Quality Assurance and Source Inspection

Contract #: 04-0120F4Cty: SF/ALA Rte: 80 PM: 13.2/13.9File #: 69.28**WELDING INSPECTION REPORT****Resident Engineer:**Pursell, Gary**Address:** 333 Burma Road**City:** Oakland, CA 94607**Report No:** WIR-009283**Date Inspected:** 28-Sep-2009**Project Name:** SAS Superstructure**OSM Arrival Time:** 700**Prime Contractor:** American Bridge/Fluor Enterprises, a JV**OSM Departure Time:** 1900**Contractor:** Zhenhua Port Machinery Company, Ltd (ZPMC), Changxing Island **Location:** Shanghai, China**CWI Name:** Chen Xi**CWI Present:** Yes No**Inspected CWI report:** Yes No N/A**Rod Oven in Use:** Yes No N/A**Electrode to specification:** Yes No N/A**Weld Procedures Followed:** Yes No N/A**Qualified Welders:** Yes No N/A**Verified Joint Fit-up:** Yes No N/A**Approved Drawings:** Yes No N/A**Approved WPS:** Yes No N/A**Delayed / Cancelled:** Yes No N/A**Bridge No:** 34-0006**Component:** OBG Crossbeams**Summary of Items Observed:**

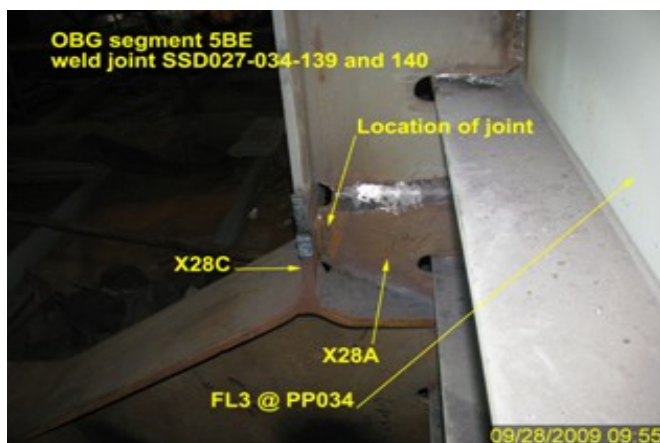
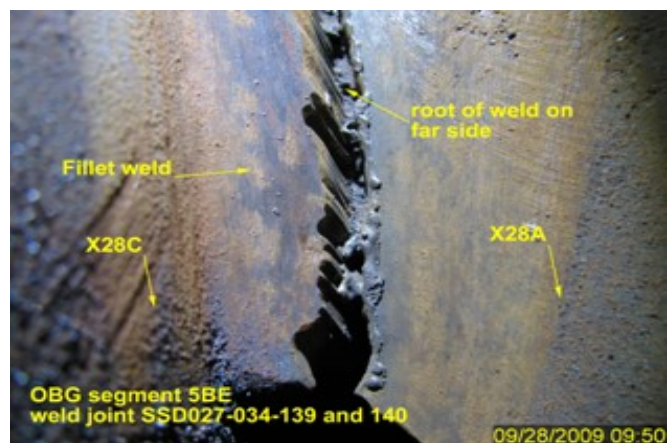
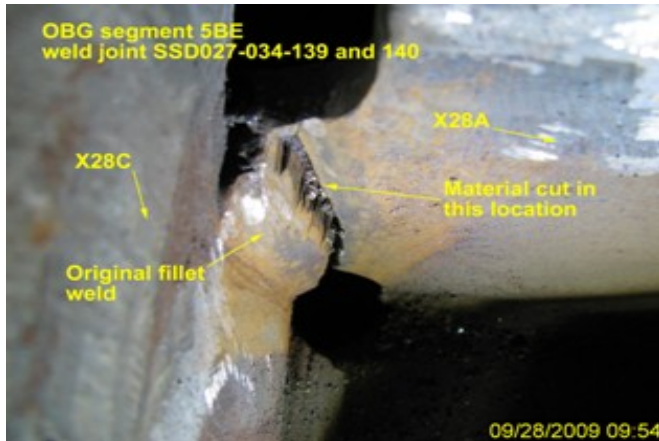
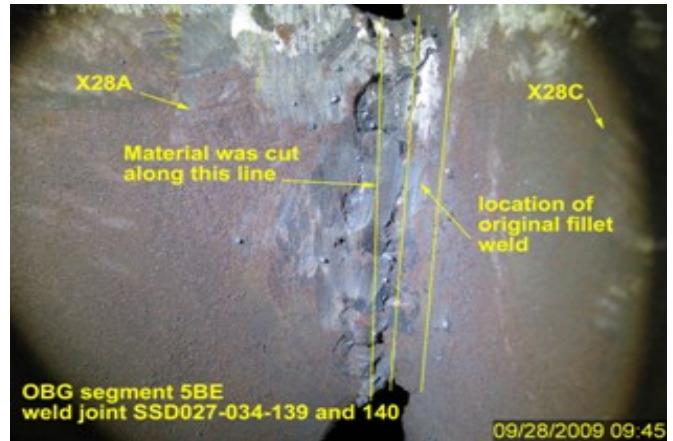
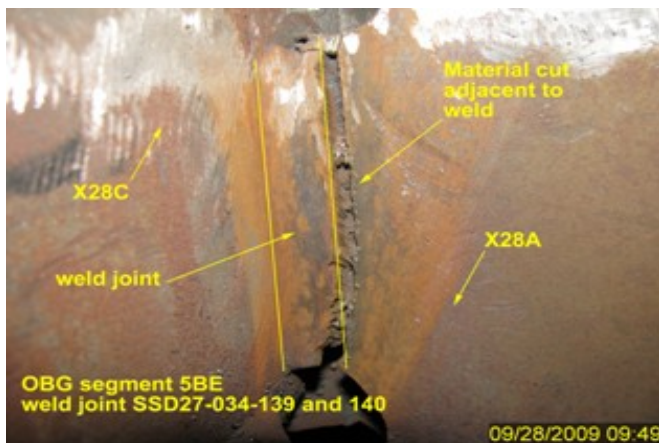
During random Visual Testing (VT) of this crossbeam and the FL3 areas of OBG lifts 5E and 5W, this QA observed the following: numerous welds that do not appear to comply with the contract documents; weld identified as SSD027-PP033-021 appears to have been cut with an oxy/fuel torch; numerous nicks and notches are still present on the cut edges of the stiffeners on the FL3 panels and several arc strikes. Most of the discrepancies appear to be confined to the FL3 areas of the east and west OBGs.

This QA observed that the contractor appears to have cut completely through the base metal of partial height floor beam diaphragm component identified as X28A. The cut was made adjacent to the fillet welds joining the web plate (X28A) to the flange (X28C). Cutting the material in this location has created the need for a Complete Joint Penetration (CJP) weld that is not designated on the approved shop drawings. The fillet weld joints in this area are identified as SSD027-034-139 and 140. AWS D1.5 2002 section 6.5.1 states "The Inspector shall make certain that the size, length, and location of all welds conform to the requirements of this code and to the detail drawings and that no unspecified welds have been added without approval". This QA informed ABF QA inspector identified as Mr. Kevin Chen and ZPMC QA identified as Mr. Wang Lu of the above mentioned issue and that an incident report would be generated. See attached photos for details.
